# **UPPER SEVIER RIVER**

## **Total Maximum Daily Load and Water Quality Management Plan**

Utah Division of Water Quality

EPA Approval Date: August 4, 2004

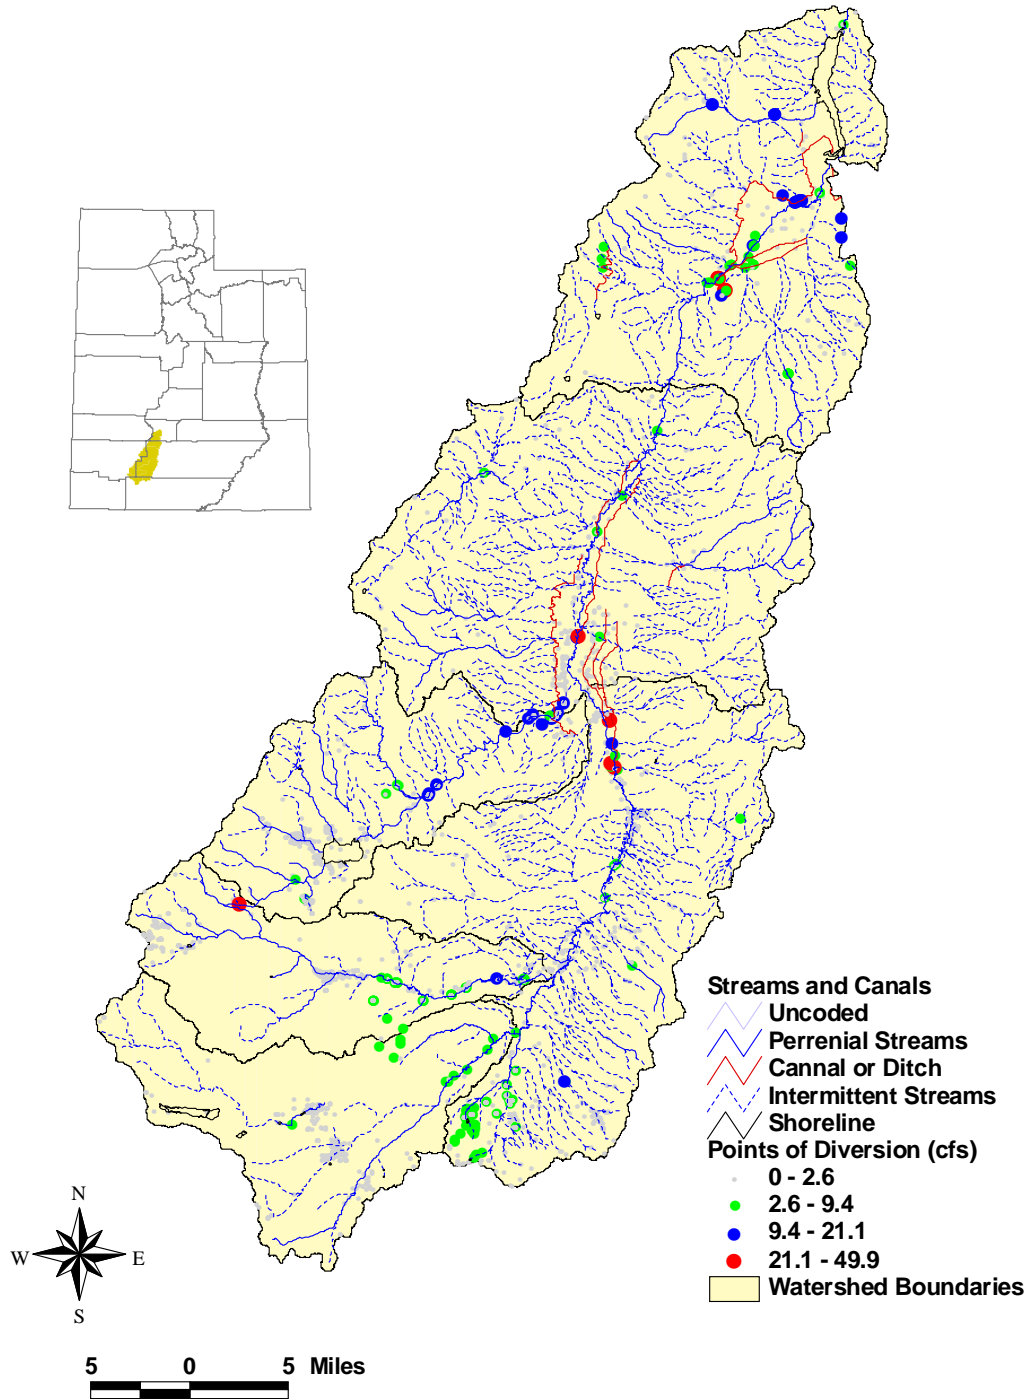
Map 3. Irrigation diversions on the Upper Sevier River and tributaries (DWR, 2003)

Available flow data for the Upper Sevier River are summarized in Figure 1. which shows the mean monthly discharge for two stations on the river located near Hatch in the upper watershed and the lower river in Circleville Canyon. With the exception of the irrigation season, flows are greater at the downstream station near Circleville. An average of approximately 68,400 acre-ft of water is diverted from the river and its tributaries in the Panguitch Valley during the irrigation season. According to a study by the Utah Department of Natural Resources (1993), of this irrigation water, approximately 33% or 22,950 acre-feet is consumed by crops. The remaining irrigation water discharges to streams and groundwater as tailwater, valley fill recharge and leakage from canals (11,110 acre-ft, 21,500 acre-ft, and 12,840 acre-ft, respectively). With the exception of a small stream section near Hatch, the length of the Upper Sevier River through Panguitch Valley is a gaining stream. The river is heavily influenced by irrigation diversions particularly near Panguitch, where several complete diversions are operated (see Map 3).

In addition, the entire flow of Panguitch Creek is diverted and used for irrigation southeast of the town of Panguitch. As a result, much of the flow in the channel downstream of Panguitch is recharge from groundwater and tailwater from irrigation. Several areas of irrigation return flow from fields were identified during SVAP surveys and were present throughout the length of the valley associated with flooded pastures.

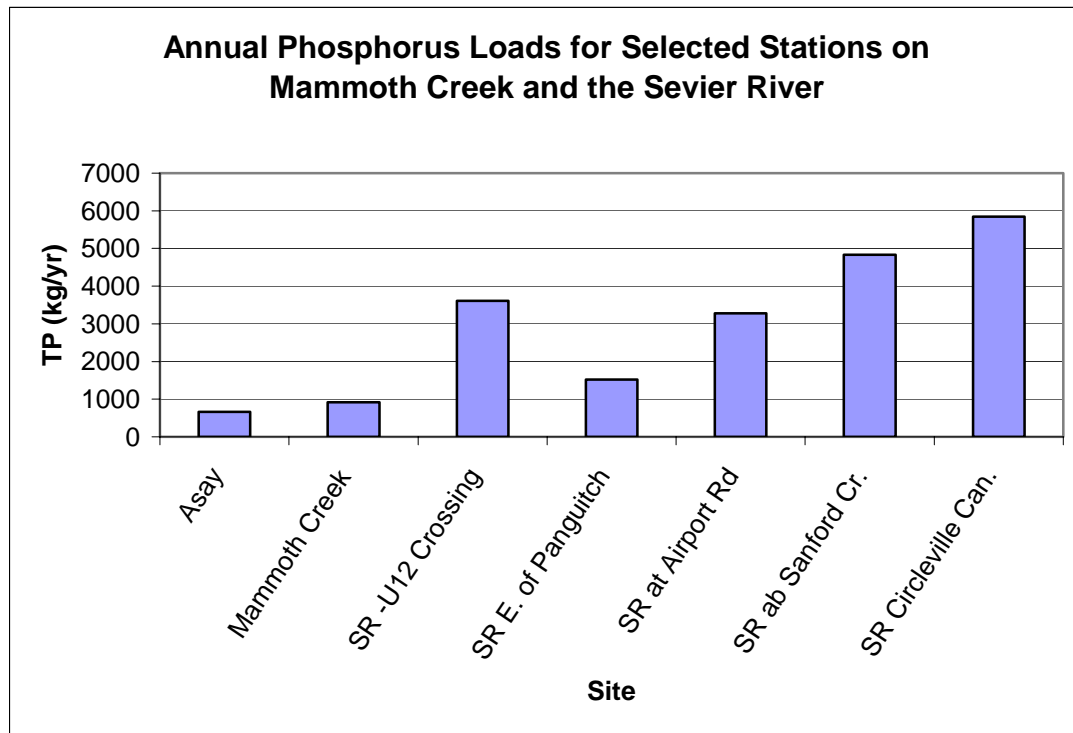
Annual loads (see Figure 4.) were calculated by averaging monthly loads and multiplying by 365 days in the year. In general, loads increase with downstream reach. The exception to this trend occurs at 494963 (Sevier River at U12 Crossing) in June which may be due to higher flows in this reach which is located upstream from major irrigation diversions. The site 494966 (Sevier River East of Panguitch) is located below a major diversion which accounts for the lower TP loads observed at this site.

Figure 4. Annual TP loads for selected stations.

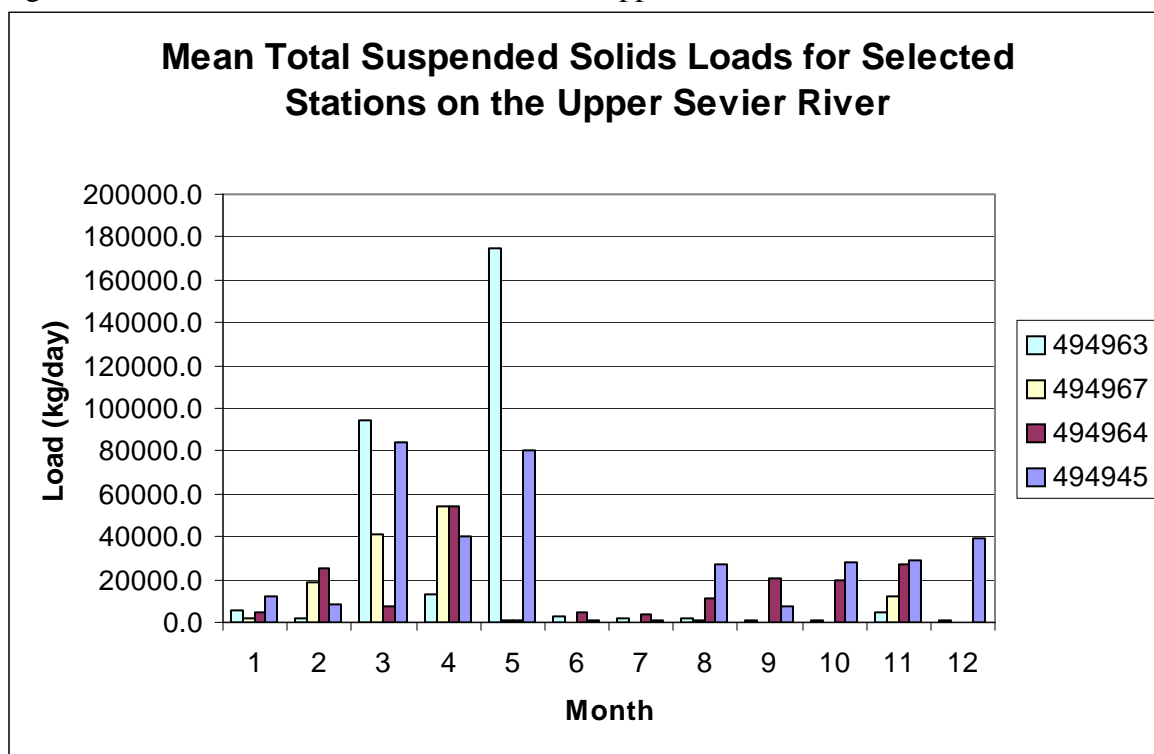
Mean total suspended solids (TSS) concentrations and loads were calculated by sorting data by month and obtaining monthly averages (see Appendix B for summaries). Figure 8 indicates that loads are highest during April and May, which corresponds with the spring runoff. The sharp drop in loading in the middle and lower river during June may reflect the effect of irrigation diversions reducing flows and concentrations due to land application of river water. Loads remain low in the upper river the remainder of the year while higher loads in the lower river reflect irrigation return flows and streambank erosion from higher fall stream flows.

Figure 8. TSS loads at selected stations on the Upper Sevier River

As is typical of stream with snowmelt dominated hydrograph, TSS values generally peak in the months of spring runoff as tributary inflows and bank erosion from high flows contribute sediment to the system. A notable exception can be seen in May values, where irrigation withdrawals not only effect discharge but the TSS load. Peaks in TSS load early in March and April may be a result of low elevation snowmelt mobilizing sediment from valley bottoms and foothill rangeland. The lower river (represented by 494964 and 494945), exhibits an increase in TSS load as stream flows increase in the lower river after irrigation season. In this situation, streambank and in- channel erosion is most likely occurring from increased flows from groundwater recharge and fall storm events. However, analysis of the correlation between flow and TSS concentrations for the period of record at 494945 did not show TSS to be well correlated to flow ( $R^2 = .28$ )

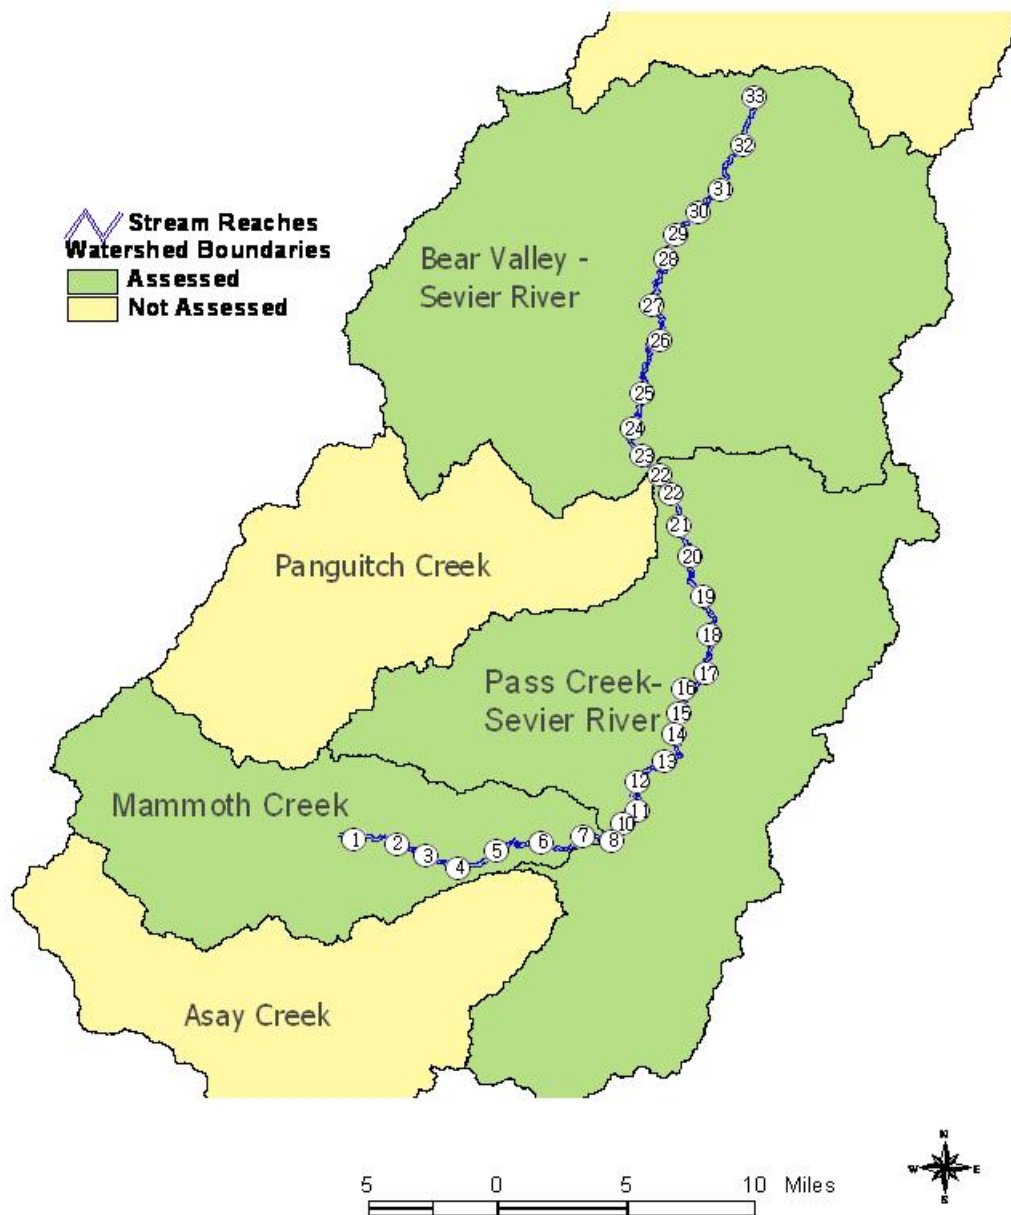
**Map 5.**

Stream reaches assessed using the Stream Visual Assessment Protocol

An extensive survey using the Stream Visualization Assessment Protocol or SVAP (USDA, 1998 ) was completed in October of 2002 on a total of 65 stream miles on the Upper Sevier River and Mammoth Creek (see Map 5). Selected results pertaining to streambank condition are contained in Table 12. In addition to SVAP additional erosion information was derived using the Streambank Erosion Condition Index or SECI (USDA,). SECI is essentially an erosion hazard index used to estimate bank erosion in

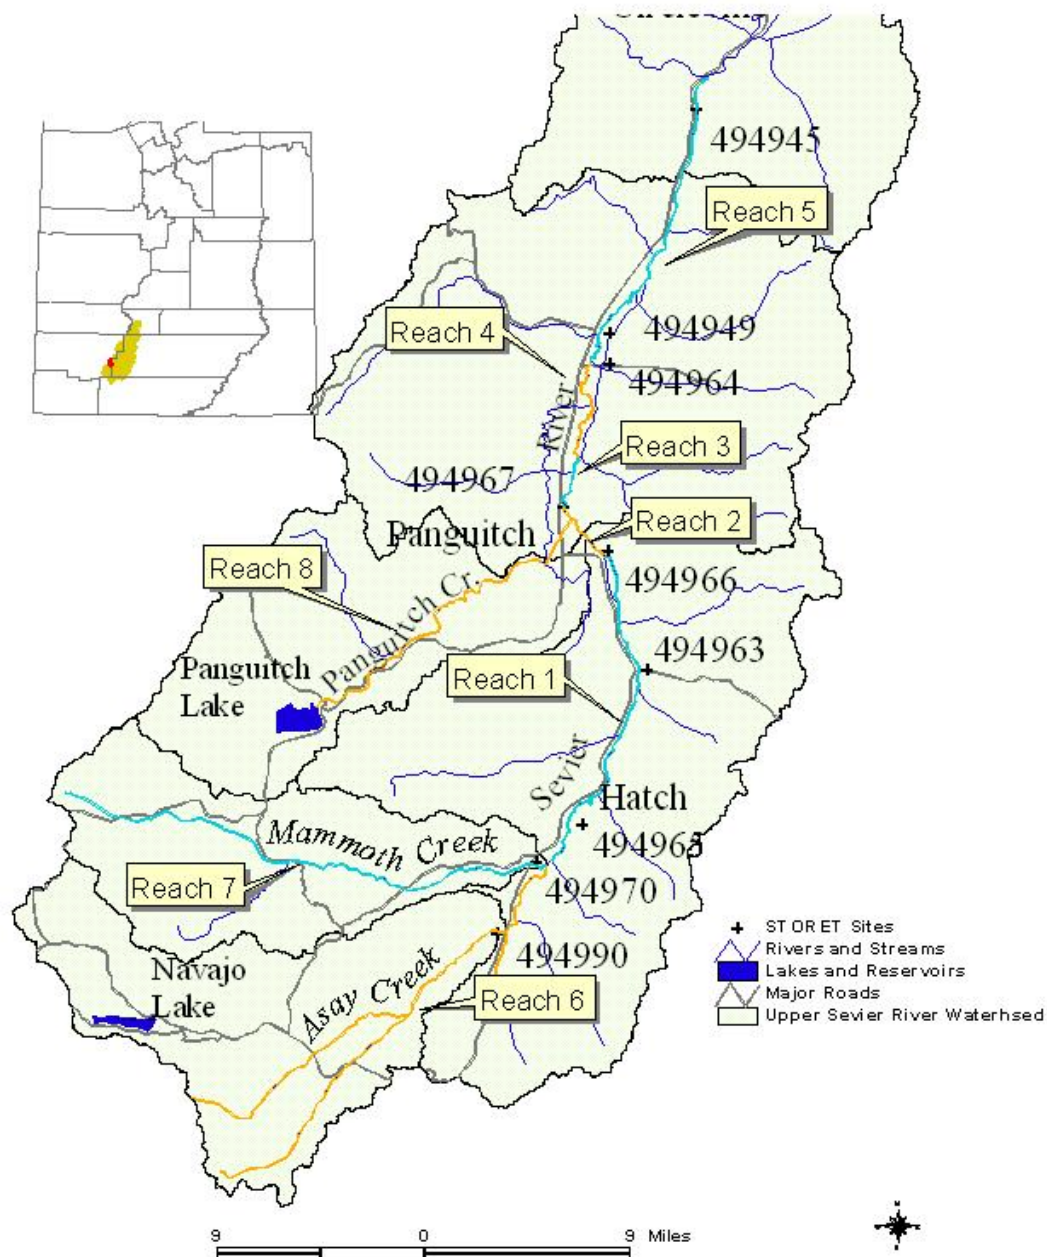
Map 6.

**Reaches assessed for cattle numbers and loading estimates.**

Overall, it was estimated that approximately 2037 kg/year of total phosphorus is attributed to the presence of cattle in the Sevier River upstream of Circleville Canyon. The load from grazing sources represents approximately 35% of the total measured annual load at the lowest STORET station of 494945. Table 14 summarizes the monthly load contribution from cattle in each reach (Note: Panguitch Creek was not included in the assessment since the stream is diverted into sprinkler systems during the majority of the year and does not likely contribute a load from cattle due to the seasonality of grazing in the Panguitch Creek watershed).

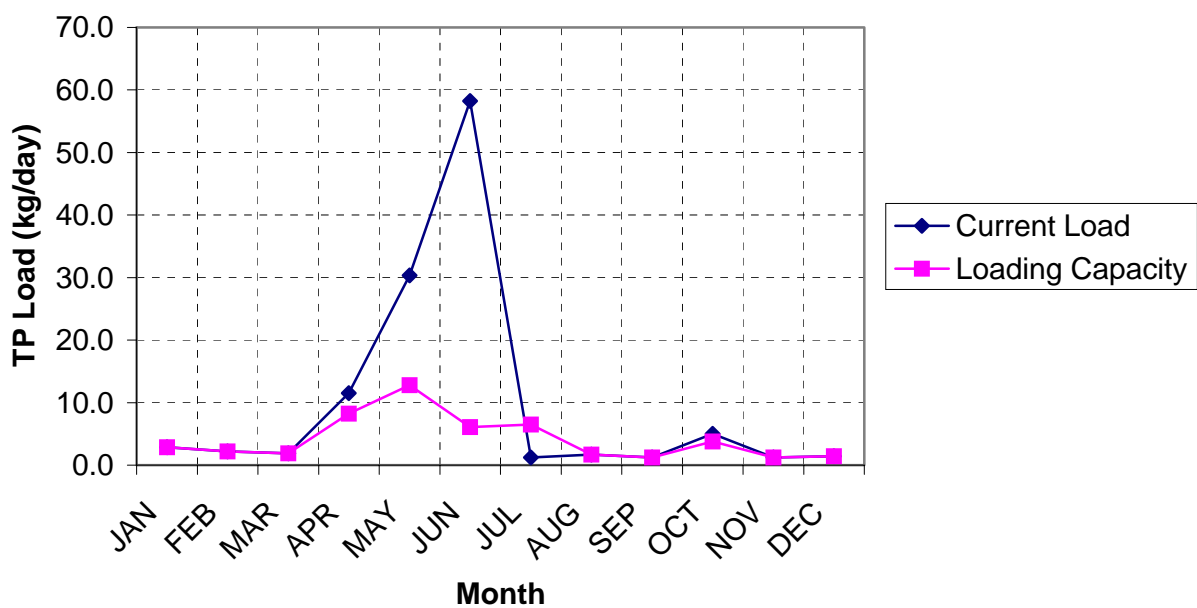
**Mean Total Phosphorus Load by Month for station 494963**

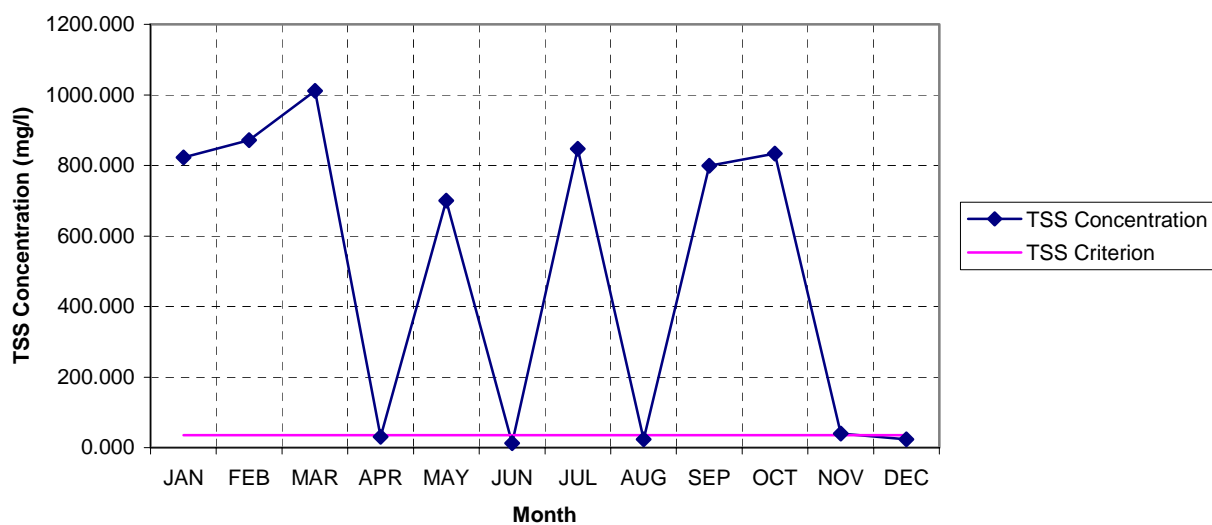
**Mean Monthly TSS Concentration for Station 494963**

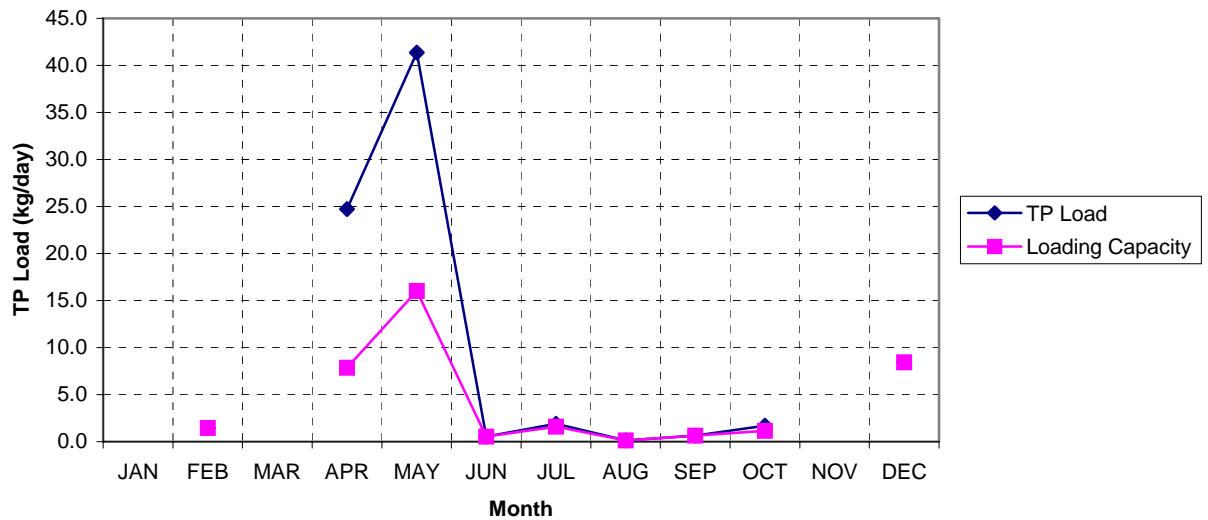
**Mean TP Load by Month for station 494967**

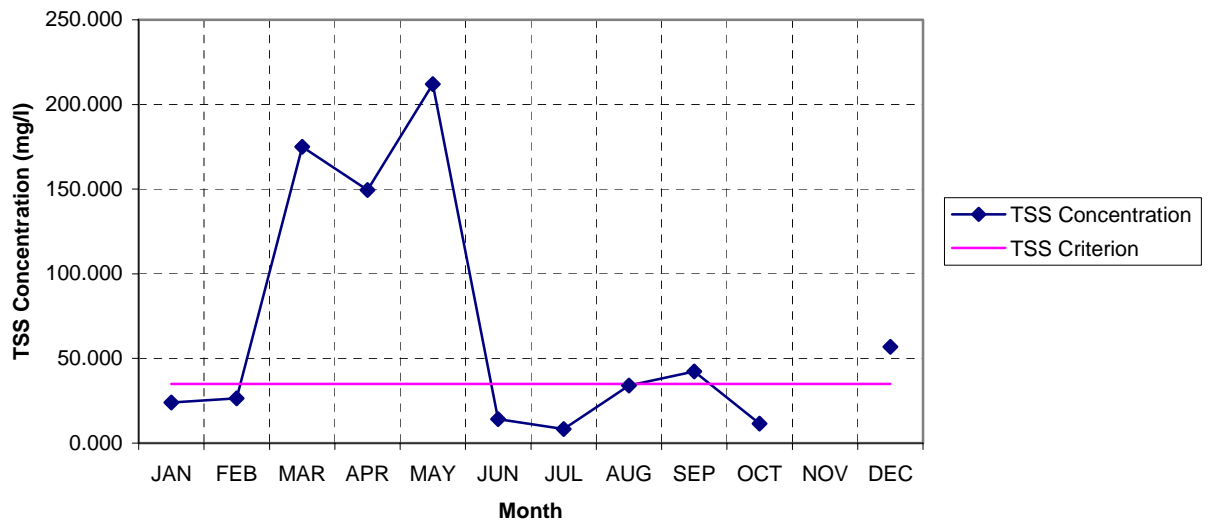
**Mean Monthly TSS Concentration for Station 494967**

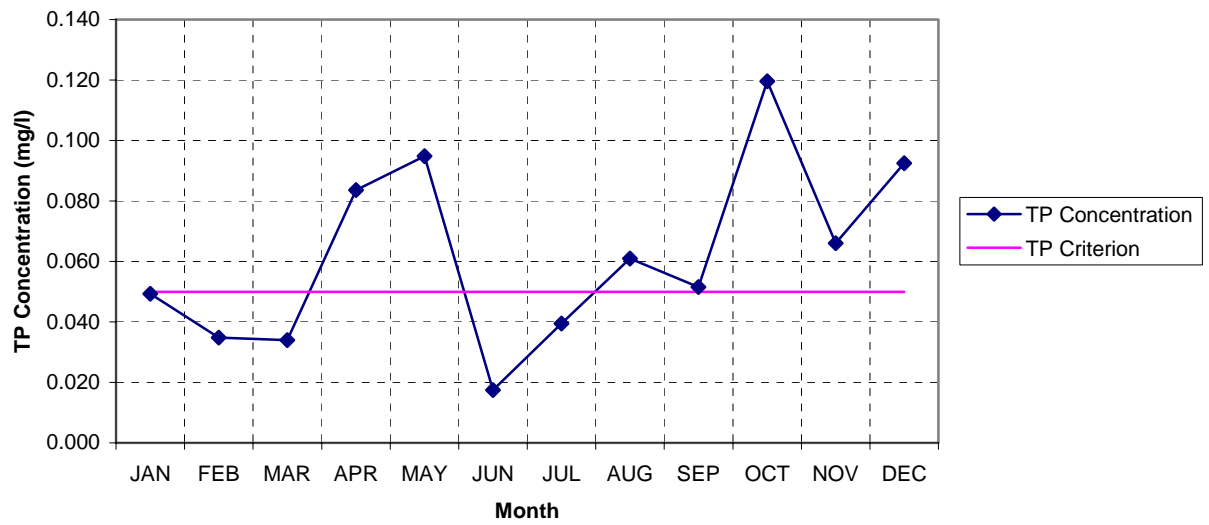
**Mean Monthly TP Concentration for Station 494964**

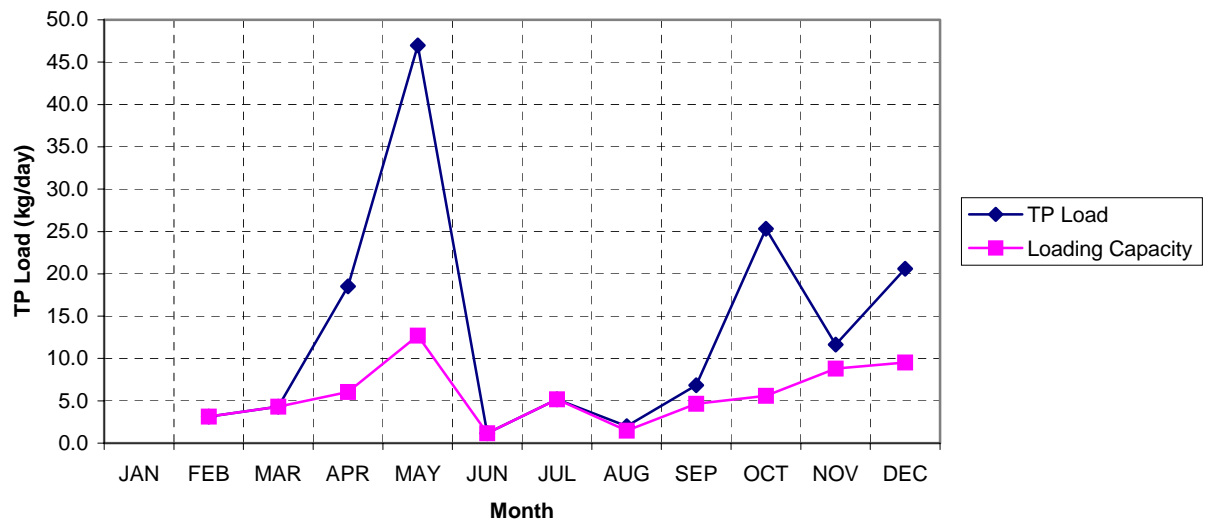
**Mean TP Load by Month for Station 494964**

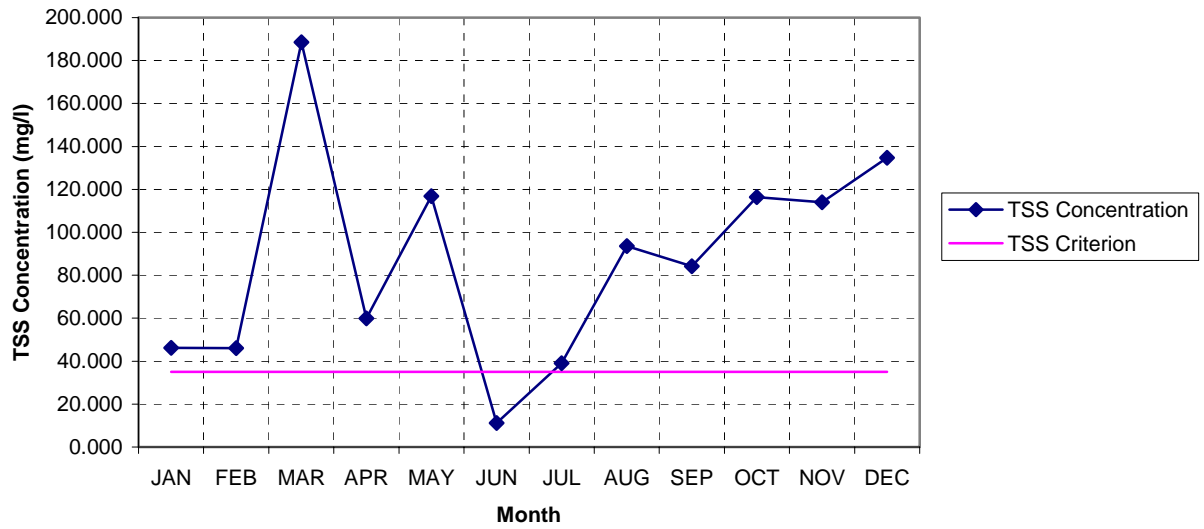
**Mean Monthly TSS Concentration for Station 494964**

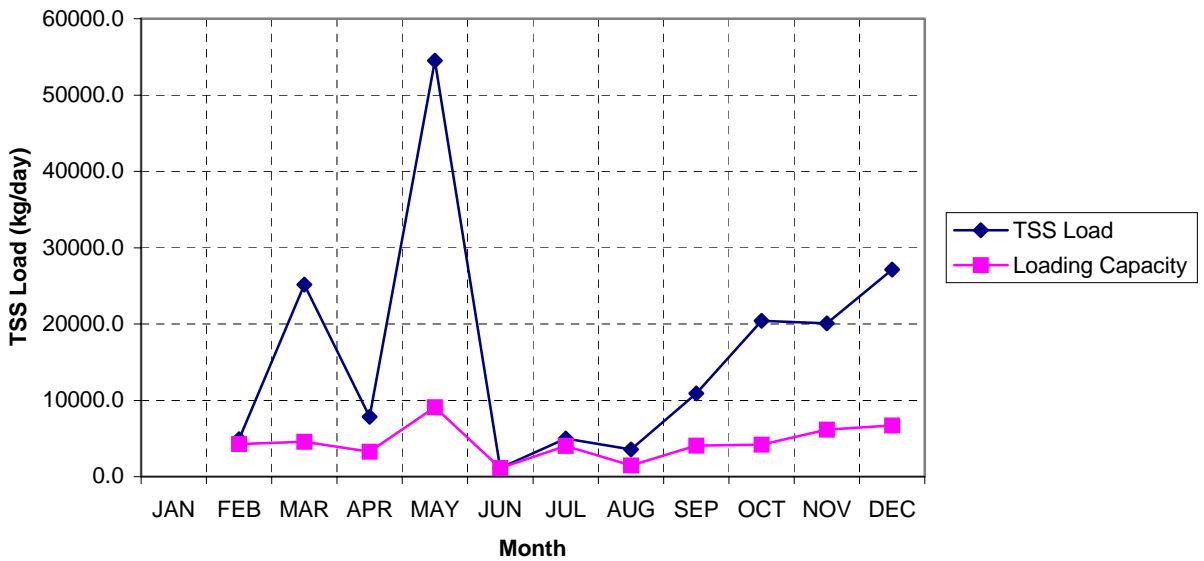
**Mean TSS Load By Month for Station 494964**

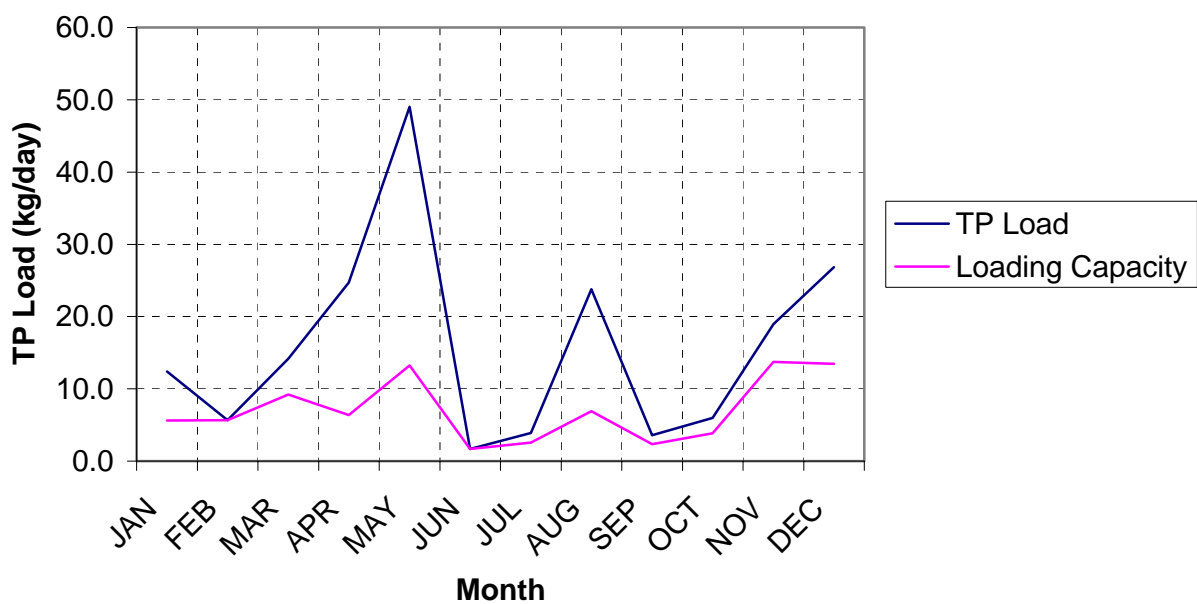
**Mean TP Load by Month for Station 494945**

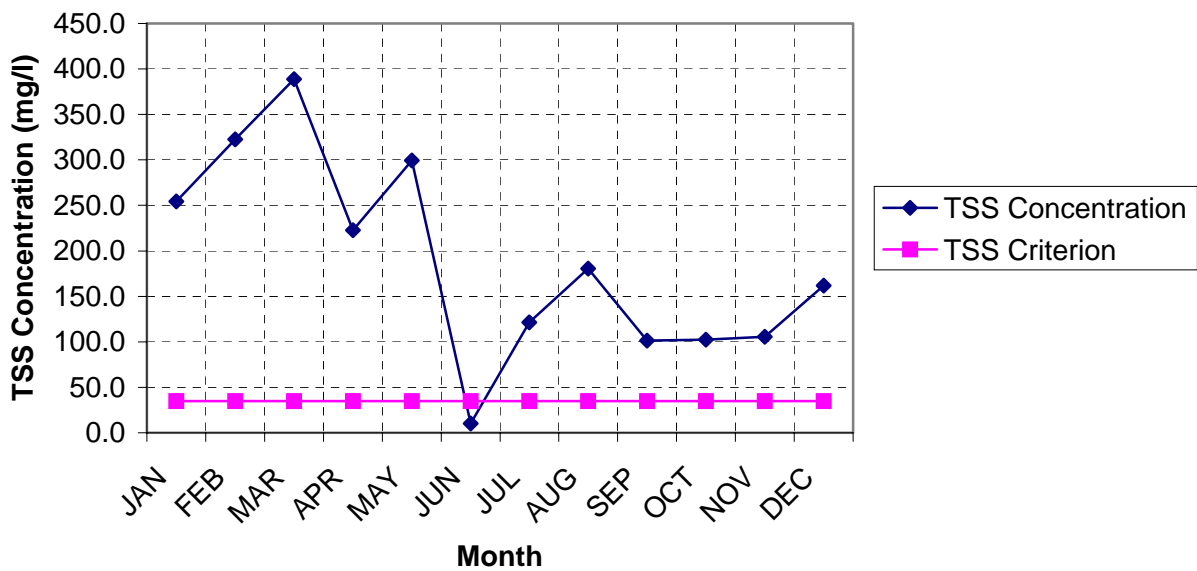
**Mean Monthly TSS Concentration for Station 494945**

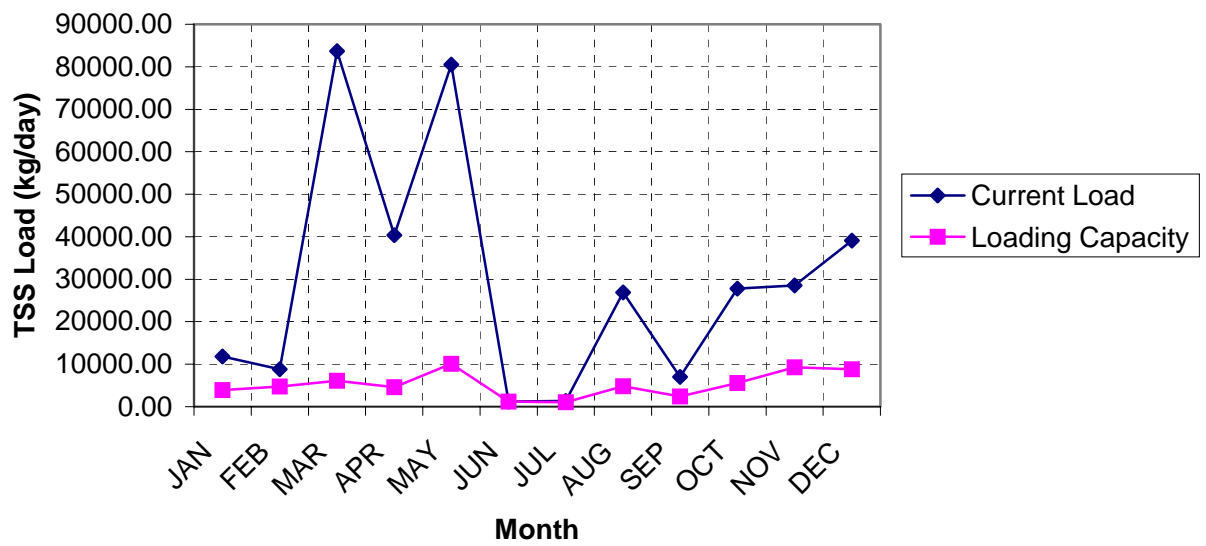
**Mean TSS Load by Month for Station 494945**
